November 27, 2024 *Revised (Final) December 18, 2024*

November 27, 2024 Revised December 18, 2024 Project No: 24-1405

Subject: Phase 1 Milestone Inspection Report Errol By The Sea Condominium 4501 South Atlantic Avenue, New Smyrna Beach, FL 32169

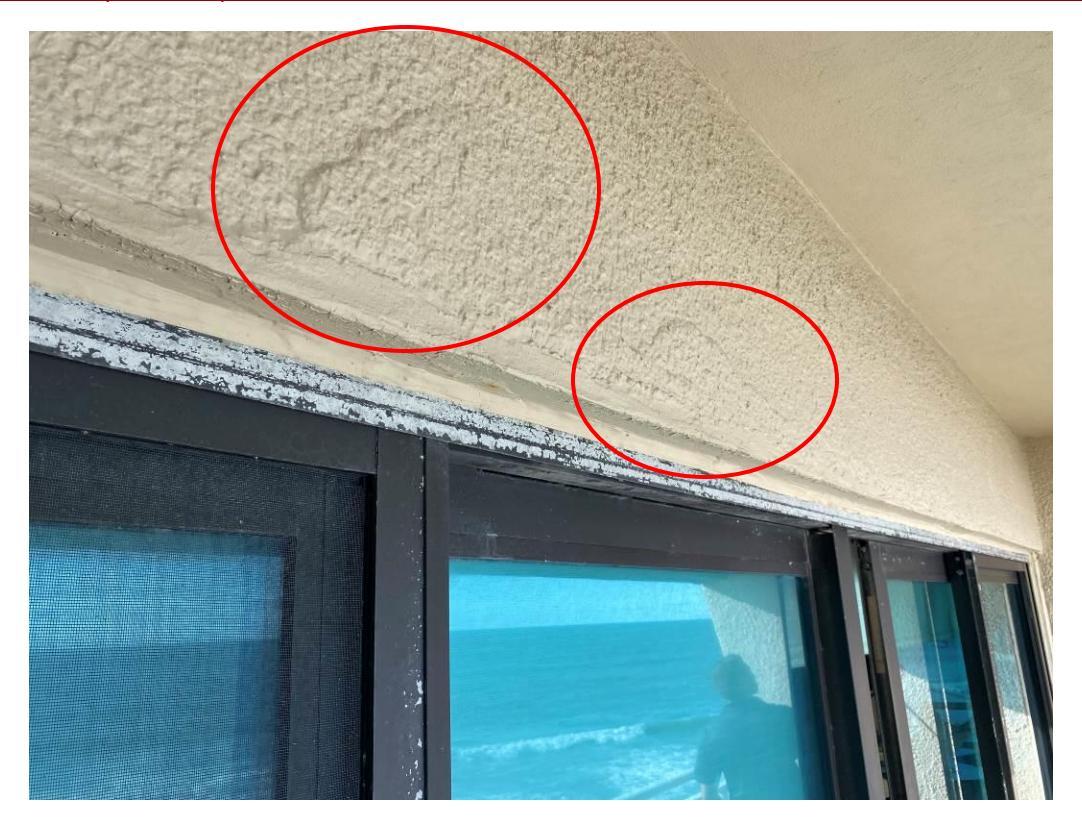
Photograph #11 – Spalling damage above balcony sliding glass door (Unit 524)

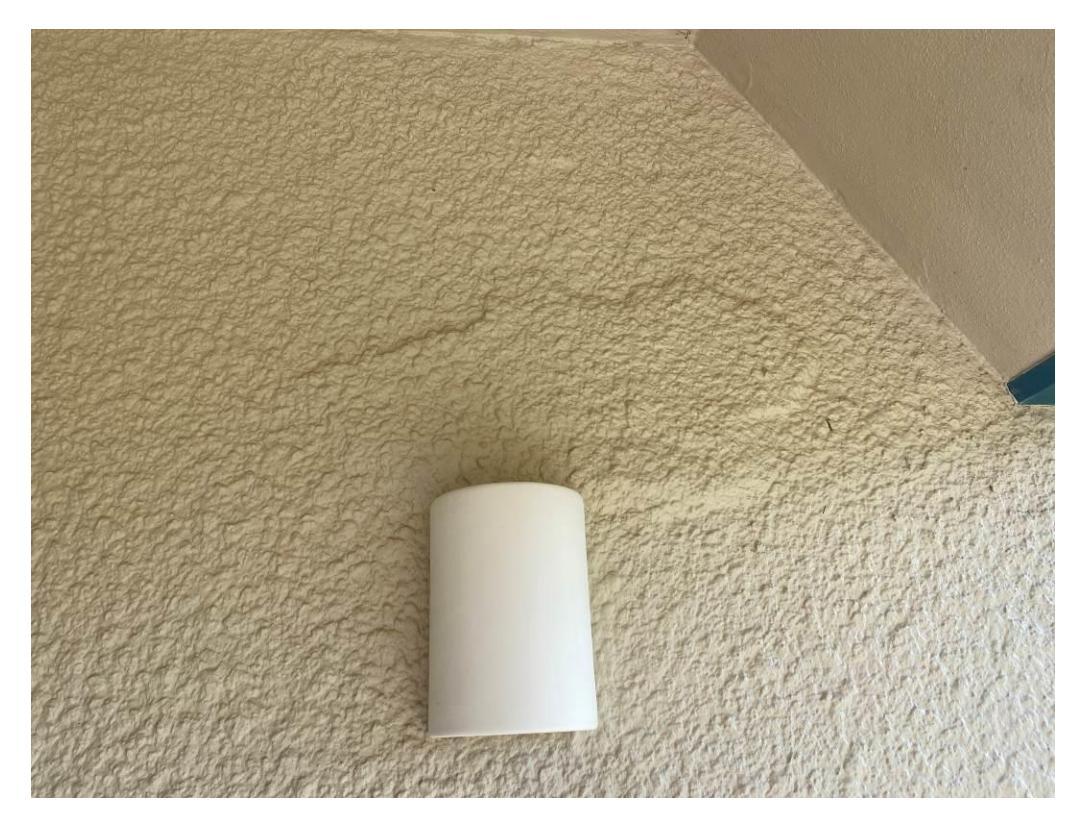
Photograph #12 – Spalling damage at balcony wall and light fixture (Unit 521)

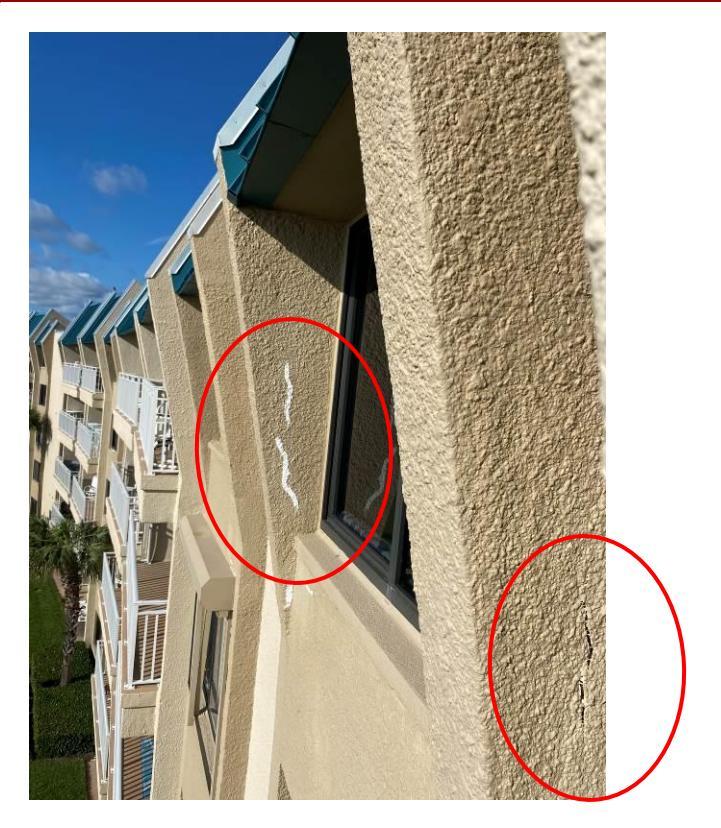
Photograph #13 – Cracking at window opening walls (Unit 522)

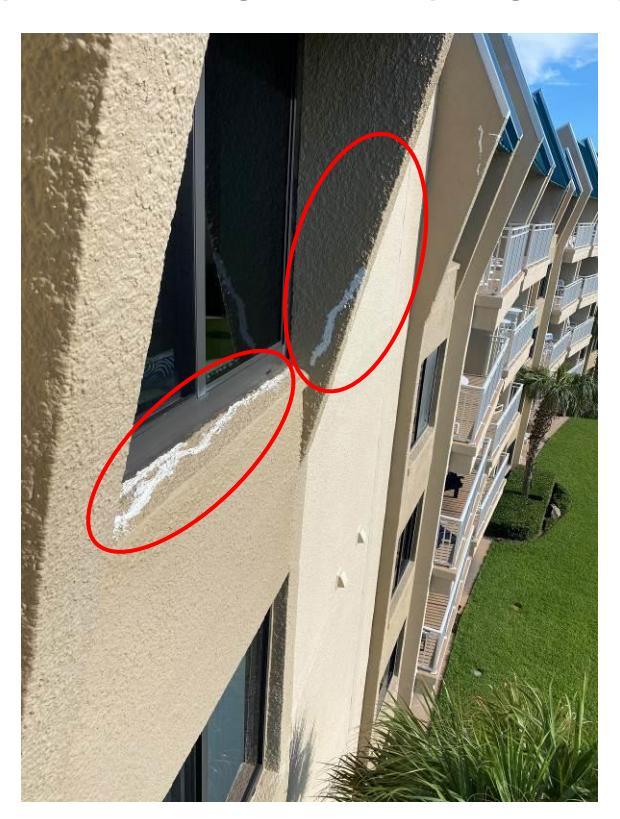
Photograph #14 – Cracking at window opening wall and sill (Unit 517)

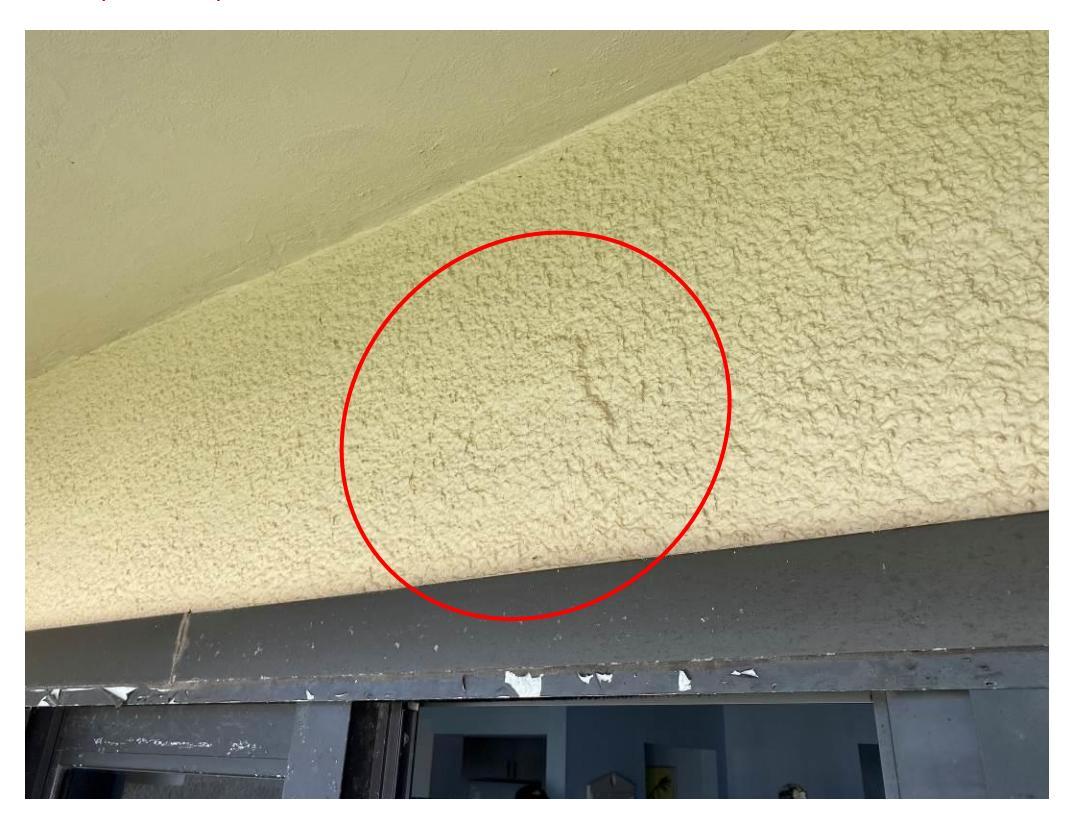
Photograph #15 – Spalling damage about sliding glass door (Unit 509)

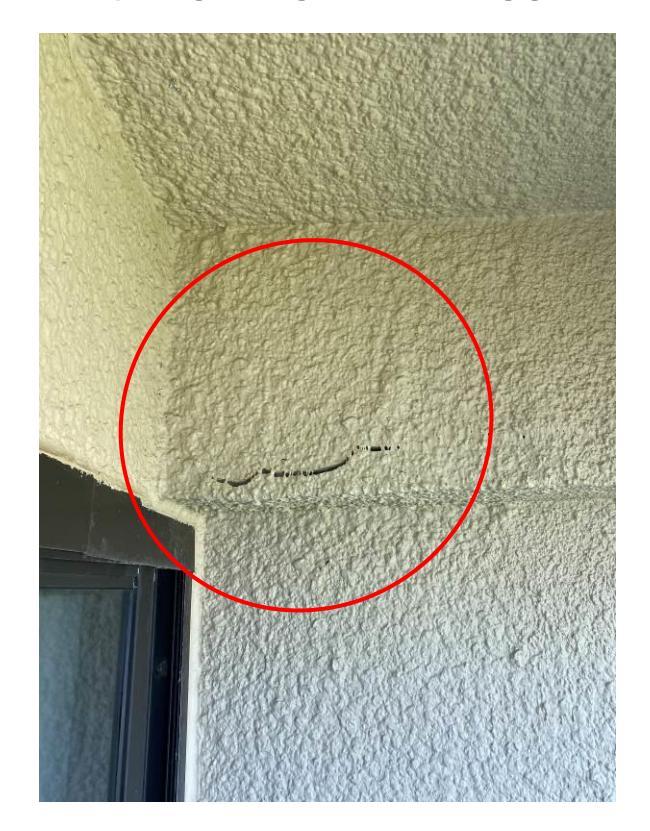
Photograph #16 – Spalling damage at balcony beam (Unit 409)

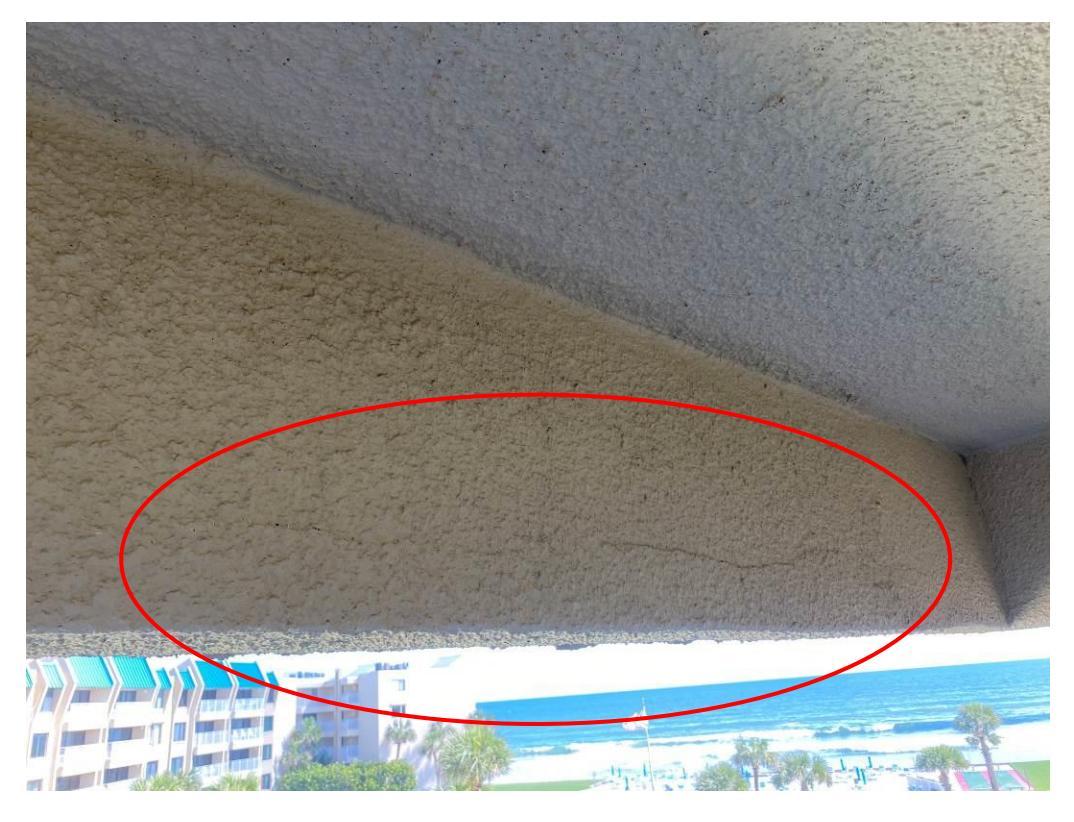
Photograph #17 – Spalling damage at balcony beam (Unit 411)

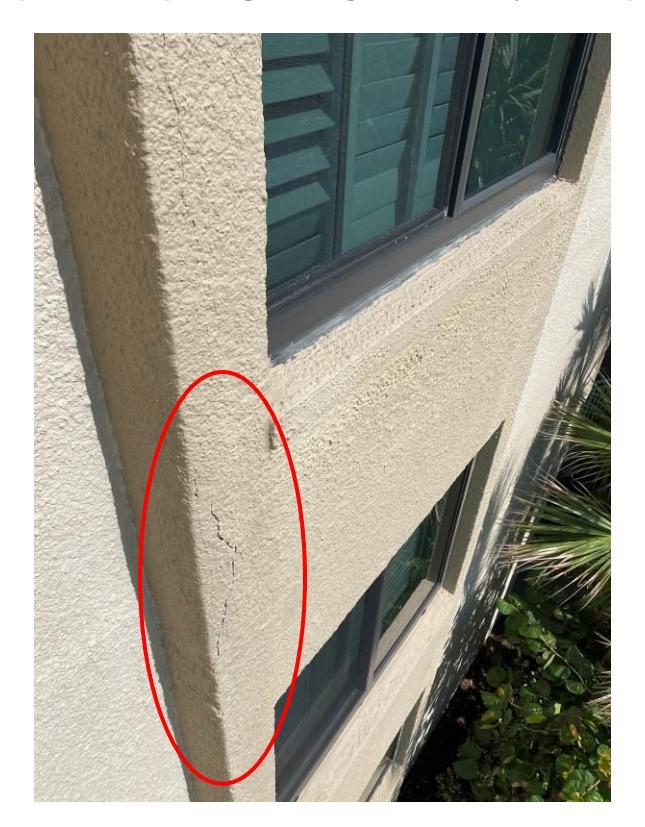
Photograph #18 – Spalling damage at wall adjacent to window (Unit 423)

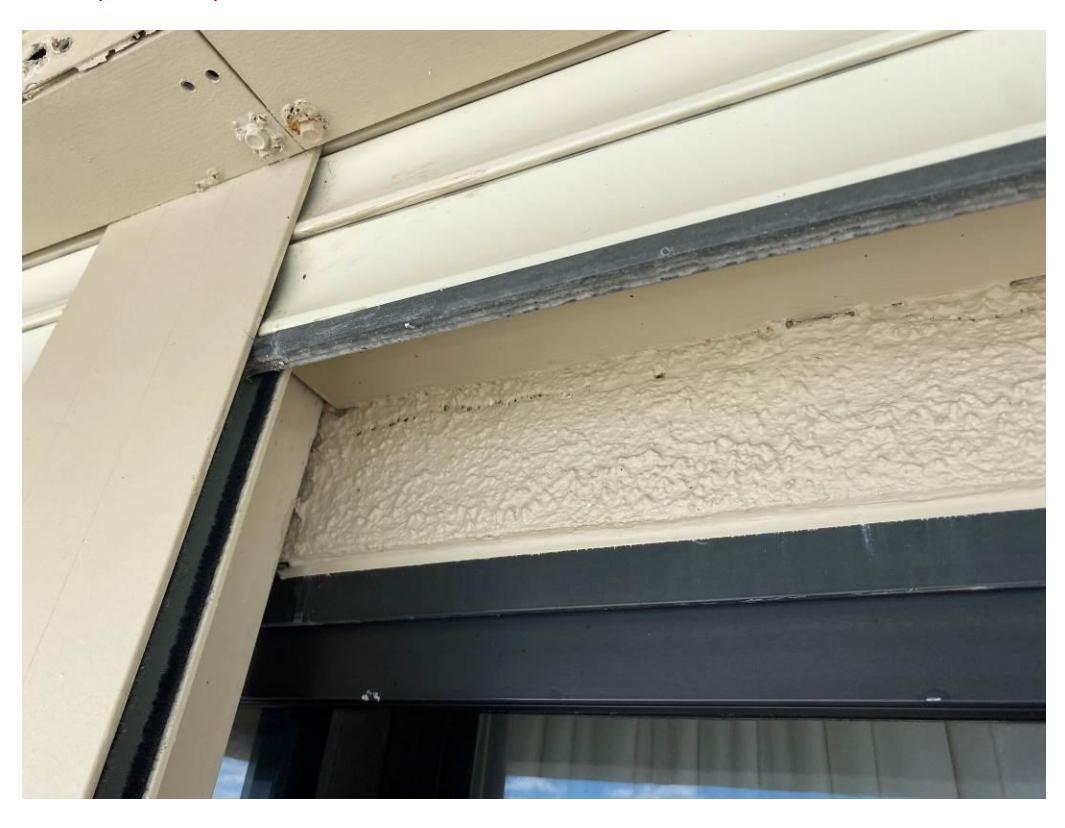
Photograph #19 – Spalling damage above sliding glass door and behind storm shutter (Unit 426)

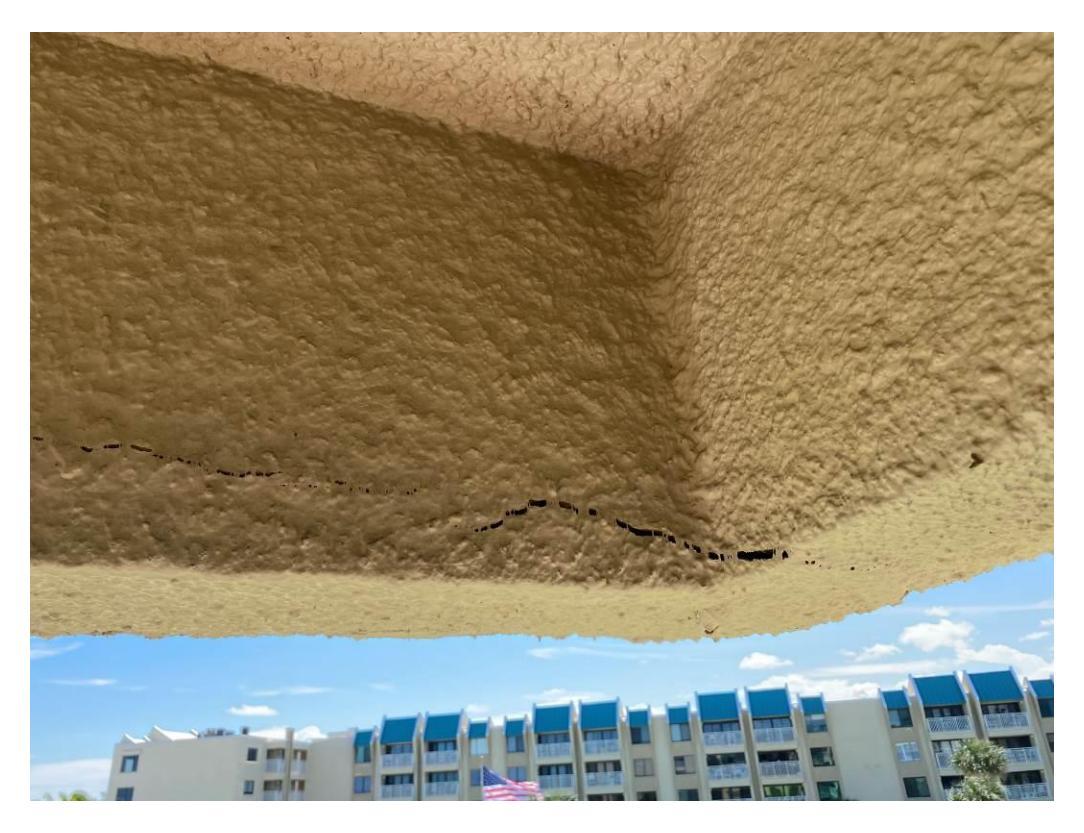
Photograph #20 – Spalling damage on balcony beam (Unit 323)

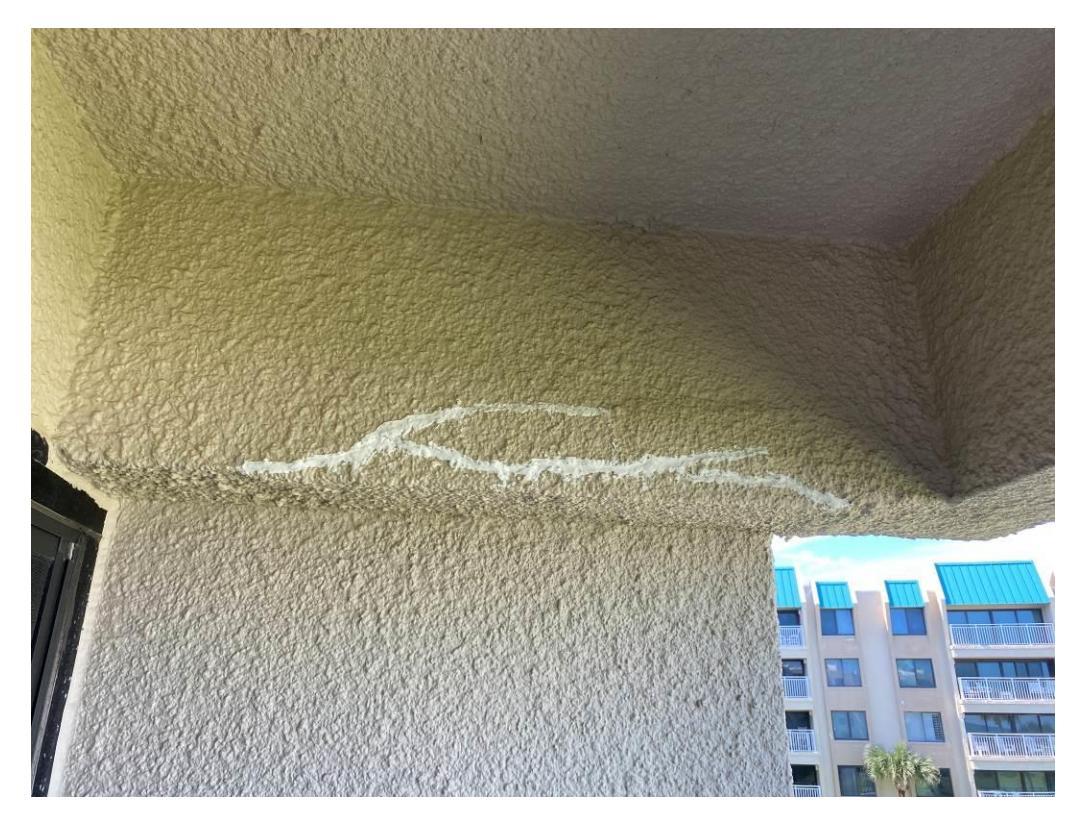
Photograph #21 – Spalling damage on balcony beam (Unit 307)

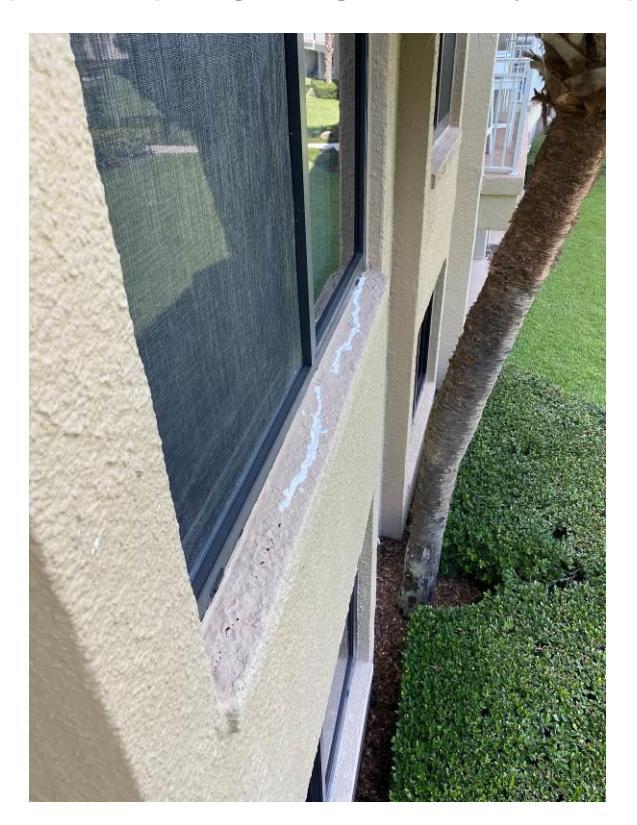
Photograph #22 – Spalling damage on window sill (Unit 215)

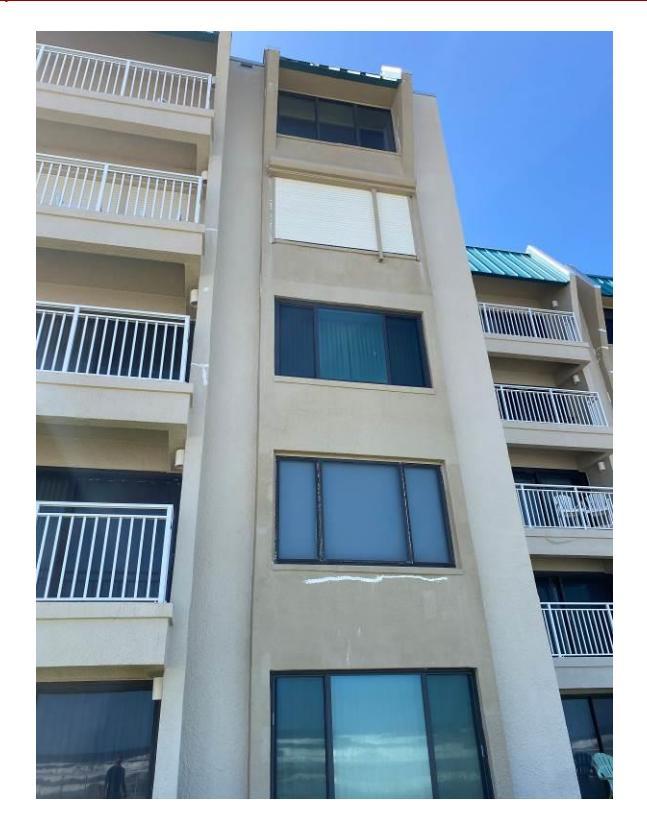
Photograph #23 – Typical balcony elevation window stack with cracking

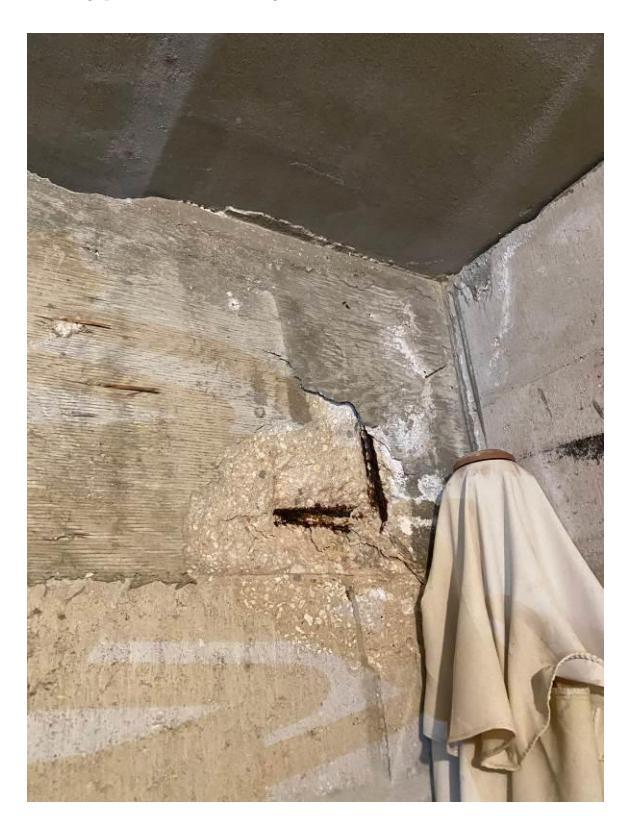
Photograph #24 – Spalling damage inside 4th floor storage room

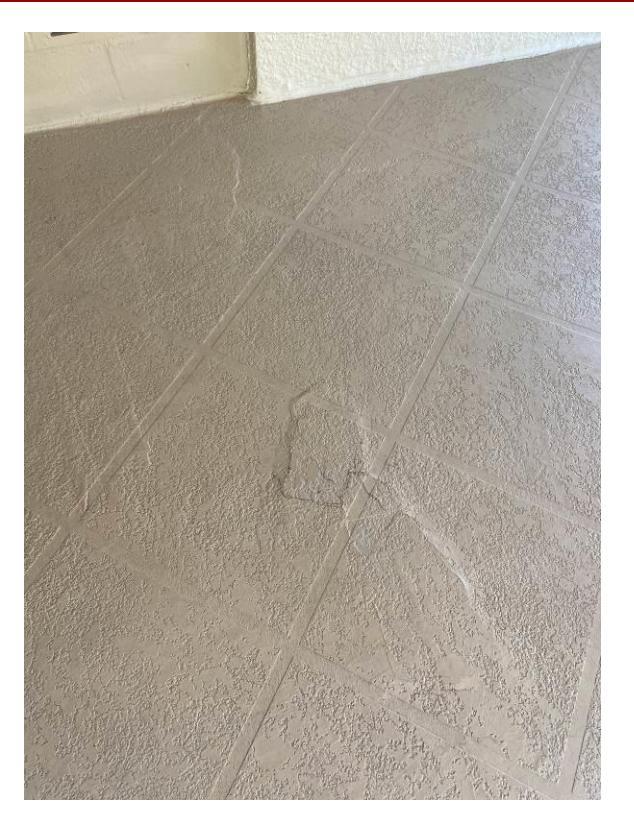
Photograph #25 – Spalling damage at top of slab near 5th floor elevator

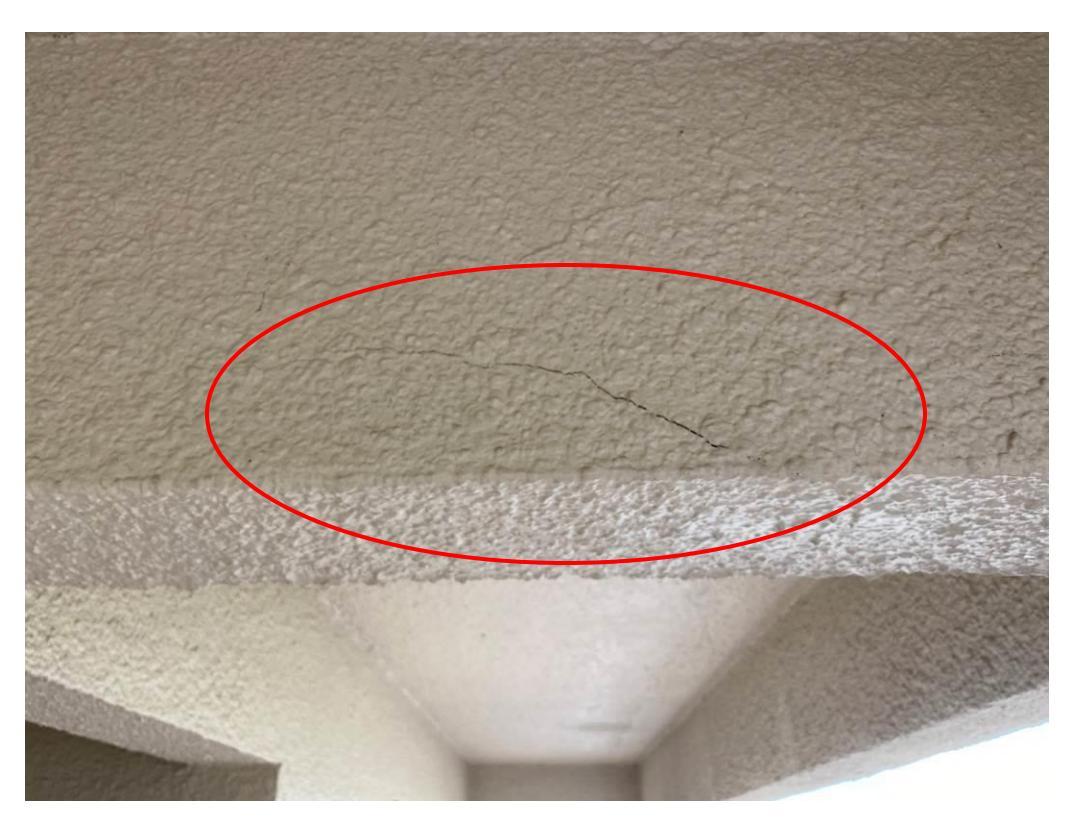
Photograph #26 – Spalling damage on walkway beam (Near Unit 515)

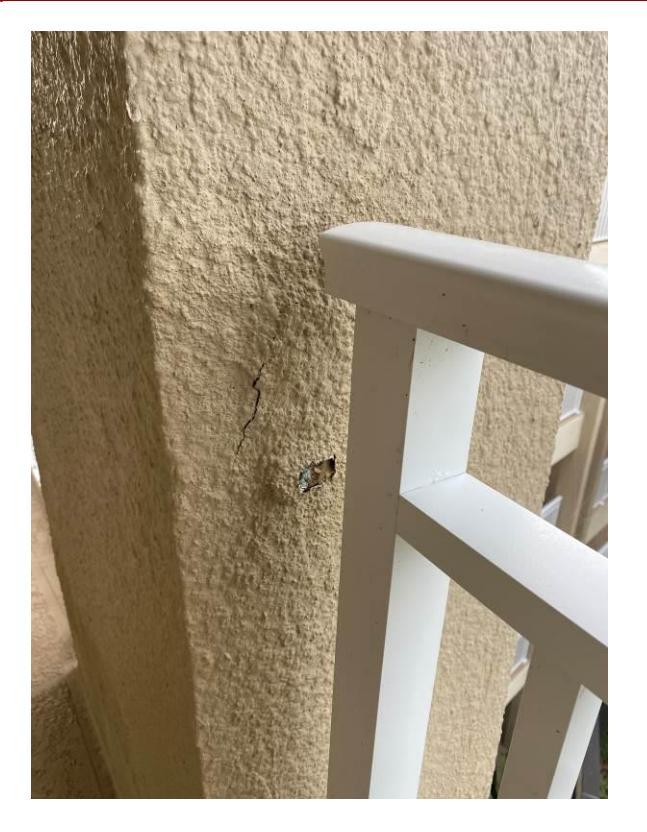
Photograph #27 – Typical cracked stucco on walkway column adjacent to guardrail

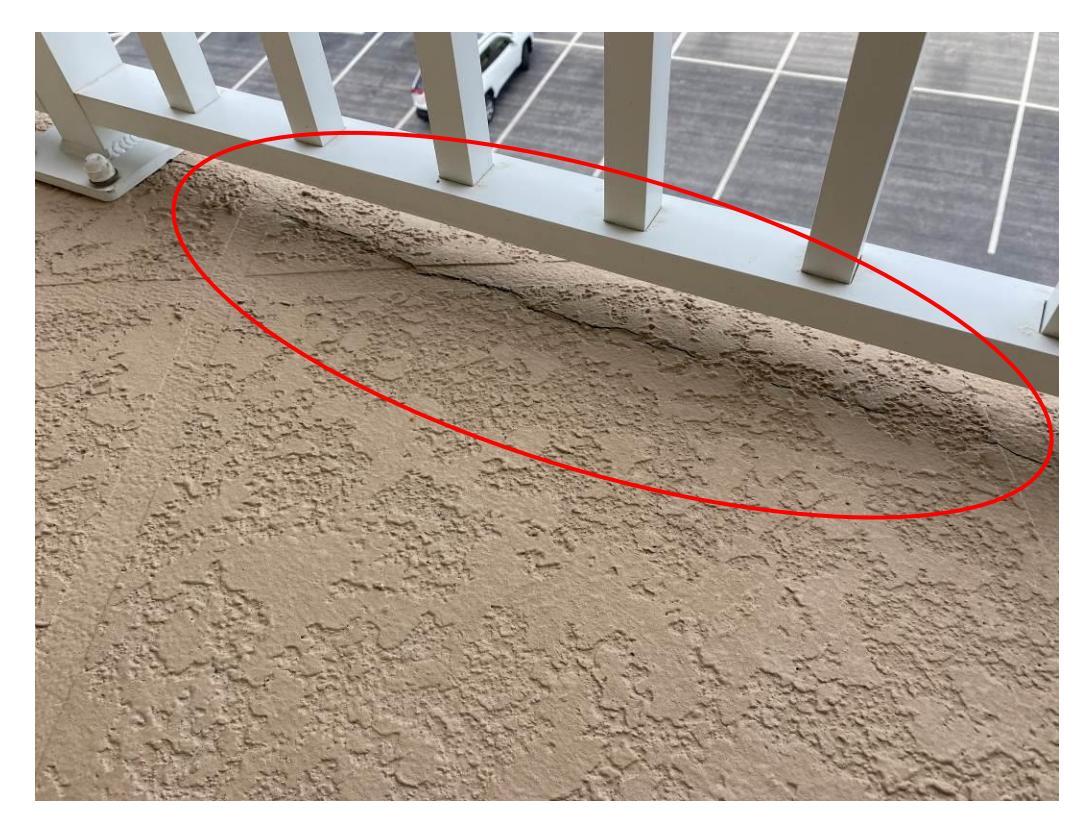
Photograph #28 – Cracking on topside of walkway slab (near Unit 519)

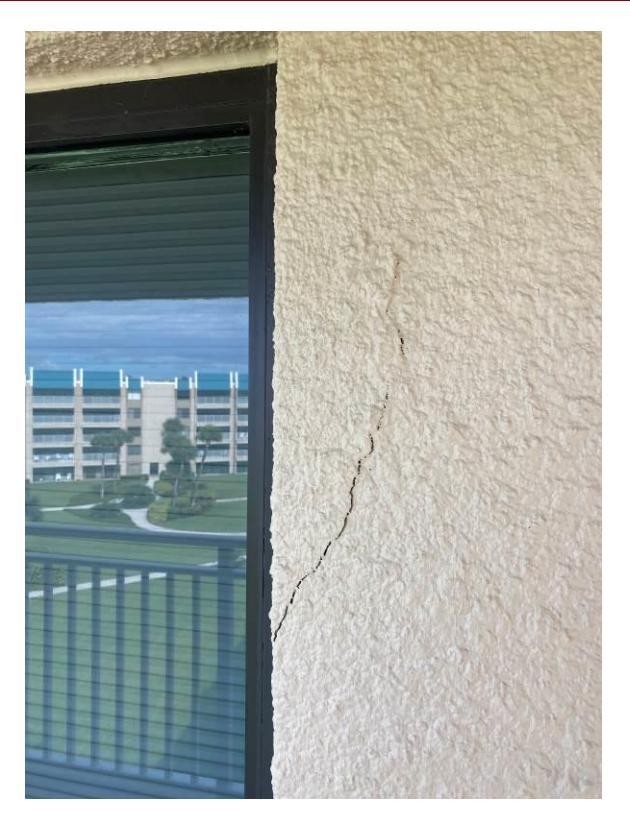
Photograph #29 – Spalling damage on wall adjacent to walkway window (Unit 501)

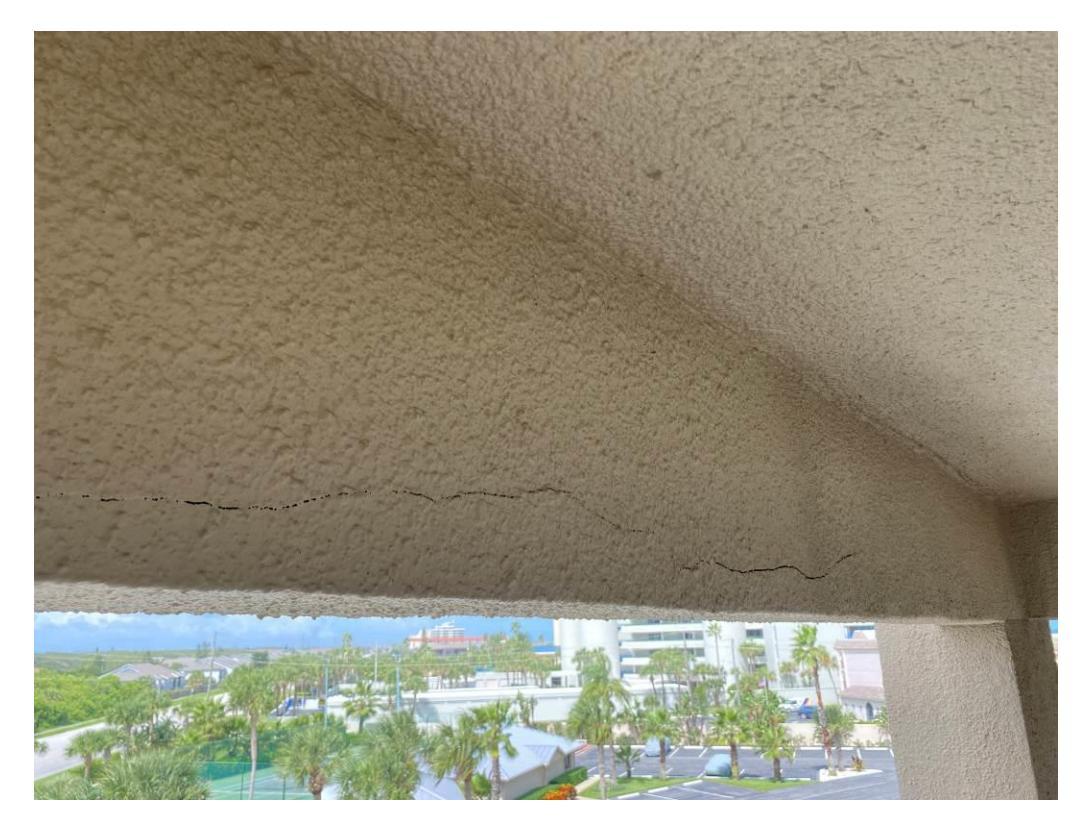
Photograph #30 – Spalling damage on walkway beam (near Unit 415)

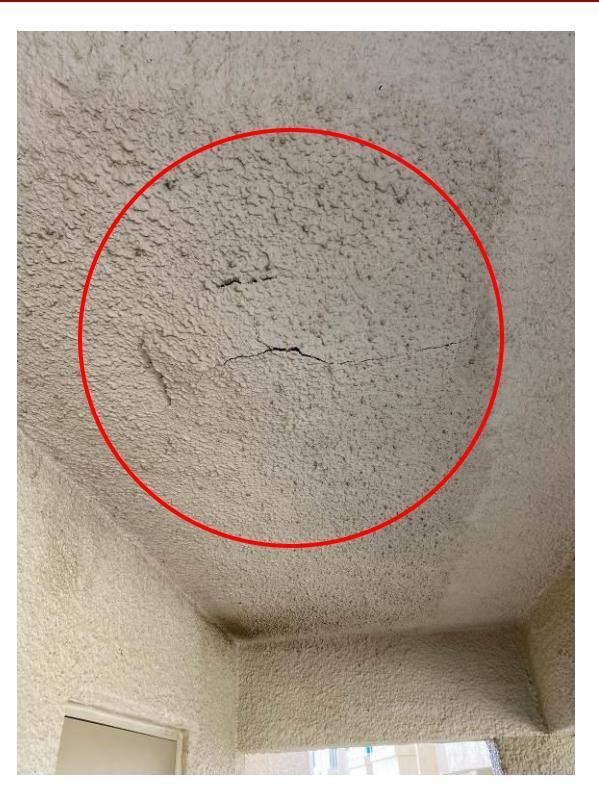
An area of spalling in need of immediate repair was identified on the 3rd floor walkway near the stairwell between the 014 and 013 unit stacks. An overhead spall was significantly cracked and is a hazard for falling debris.

Photograph #31 – Overhead ceiling spalling damage near storage closet "3W" recommended for immediate action.

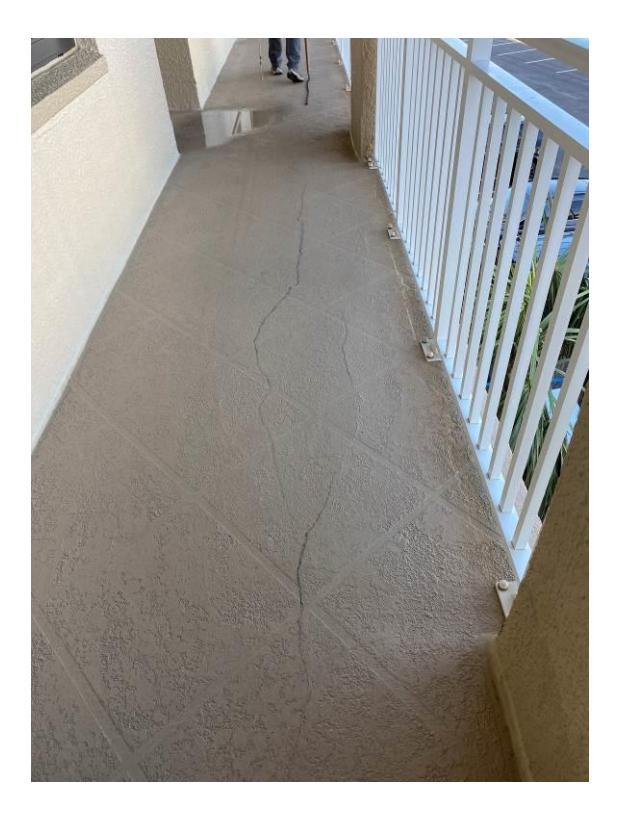
Photograph #32 – Cracking on the topside of the walkway slab (3rd floor)

The sealant around windows and sliding glass doors should be replaced. Concrete repairs will likely remove or damage sections of the coating. Where the coating is breached, new polyurethane deck coating should be re-applied to achieve a continuous waterproof system on the top of the slabs.

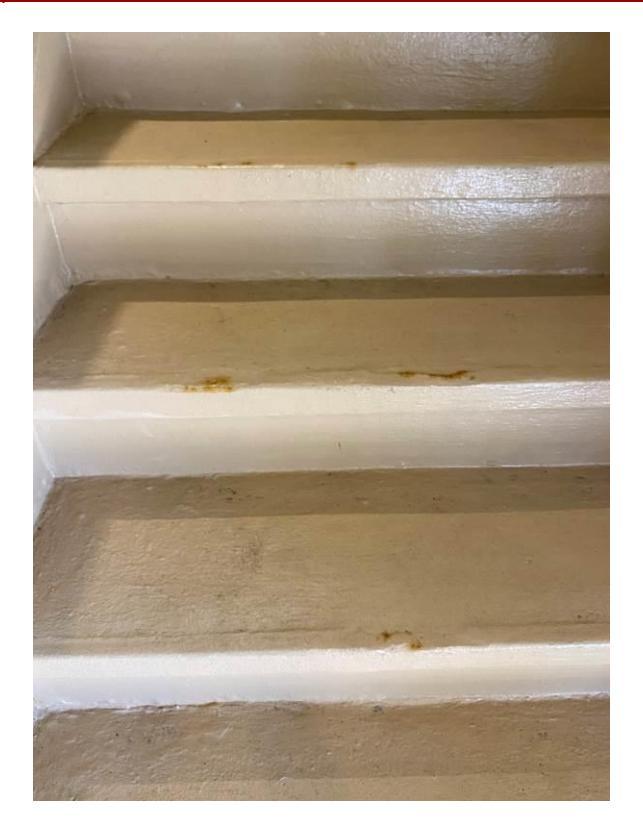
<u>Stairwells</u>: The metal framing at the stairwells was exhibiting light rust on the underside of the stair structural framing and on the topside of the stair tread nosing.

Photograph #33– Typical mild rusting at stairwell metal framing

The metal framing at the stairwells should continue to be maintained. Areas of rust should be cleaned and painted for projection.

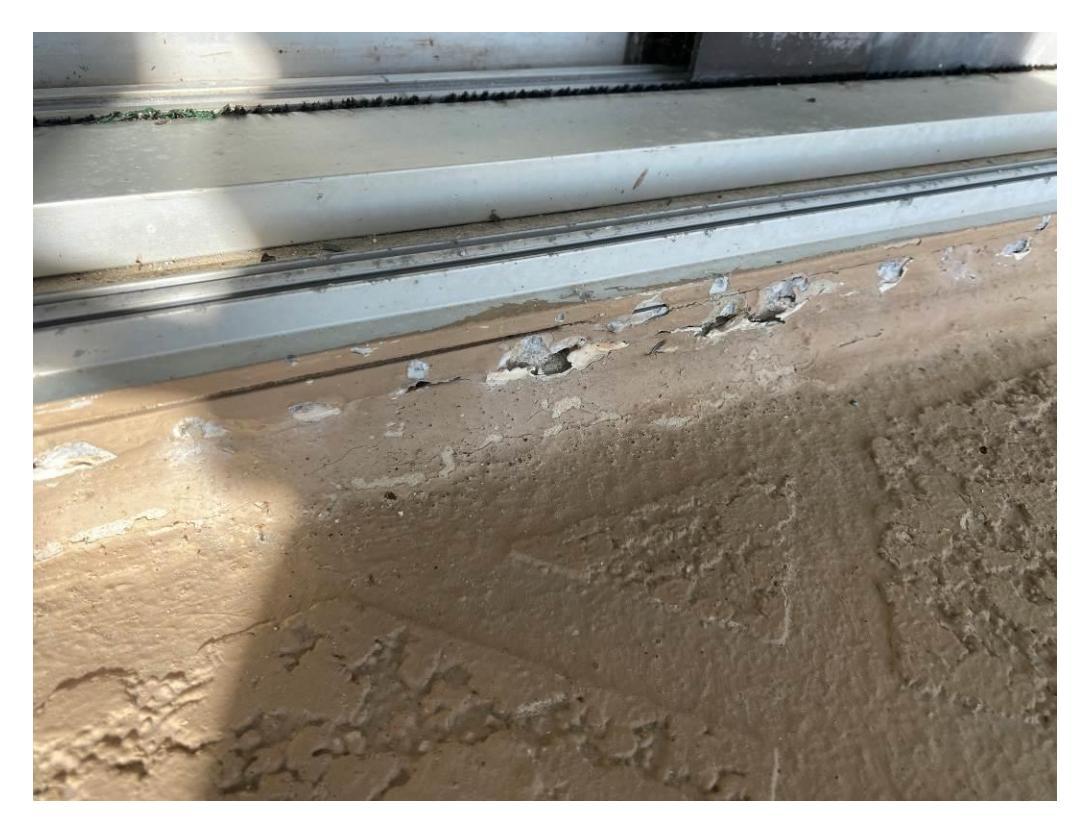
Photograph #34 – Failed sealant at oxidized sliding glass door frame (Unit 524)

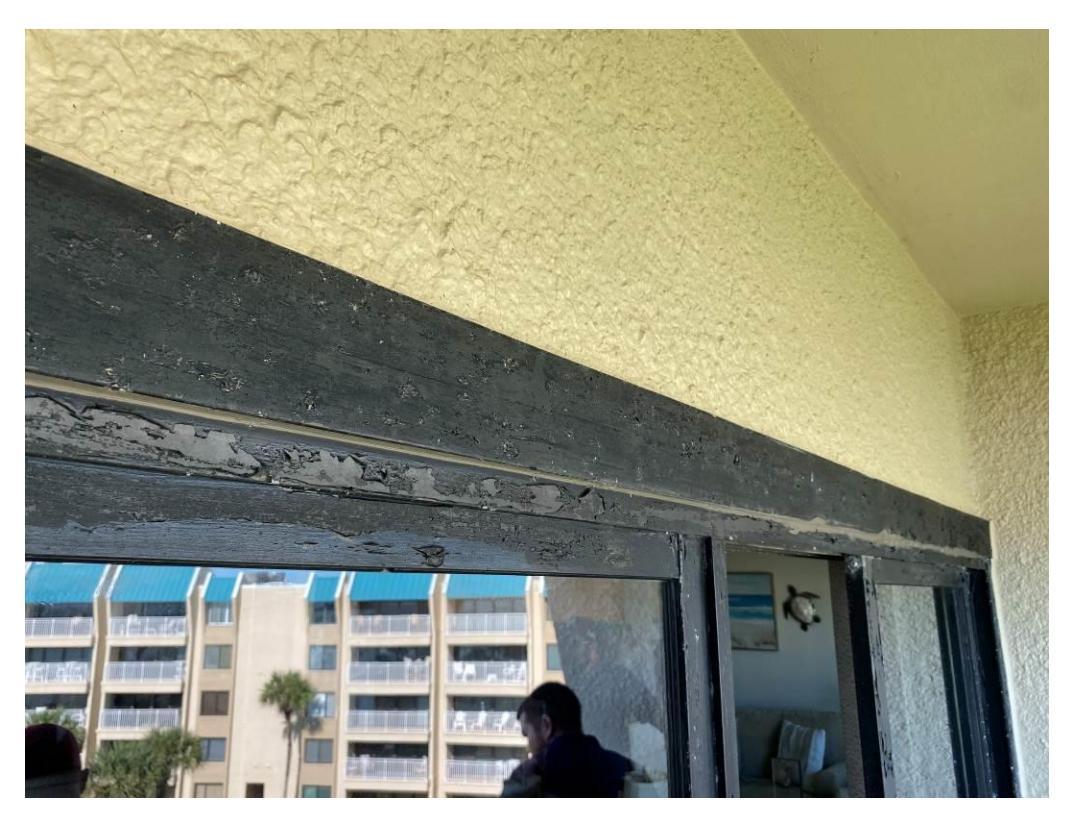
Photograph #35 – Failing sliding glass door finish (Unit 508)

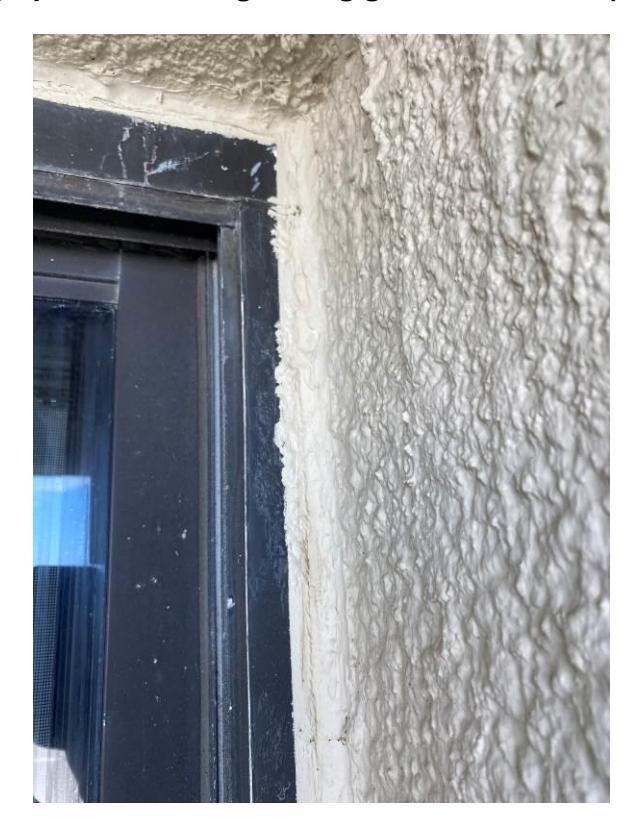
Photograph #36 – Failed sliding glass door finish and deteriorated sealant (Unit 224)

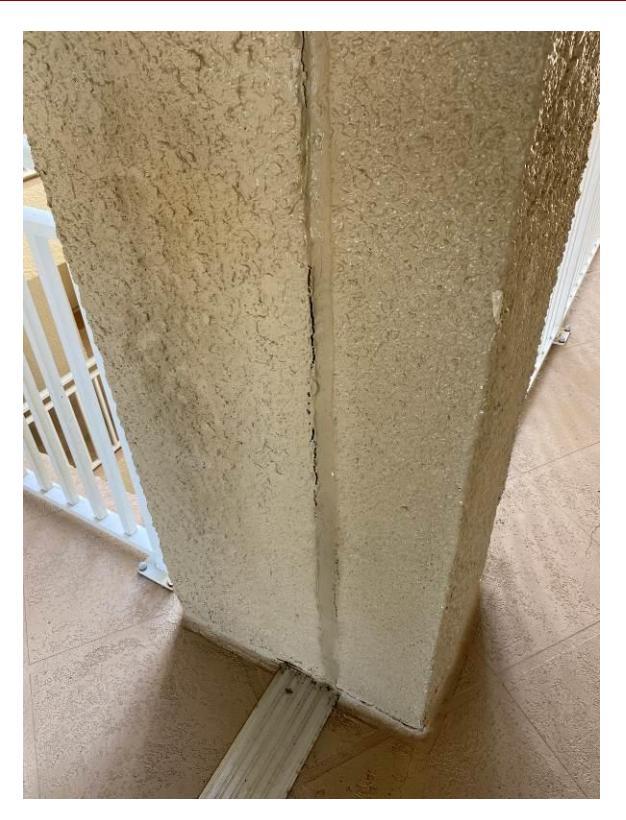
The expansion joint sealants at the walkways were commonly failing in adhesion. Rust spots, caused by ferrous metals at the surface of the paint finish, were observed at the balcony and walkway elevations.

Photograph #37 – Typical failed expansion joint sealant

The expansion joint sealants should be replaced with a flexible polyurethane sealant.
